OPTIMAL®

Unacceptable:

Severe damage/unauthorised repairs:

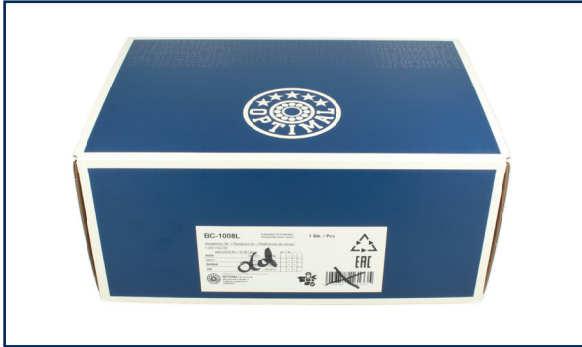
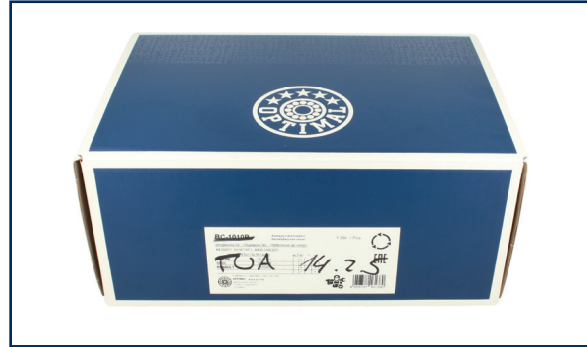
Illegible barcode:

The original barcode on the box must not be covered in any way. The brake calipers will be rejected if the barcode cannot be read by a scanner.

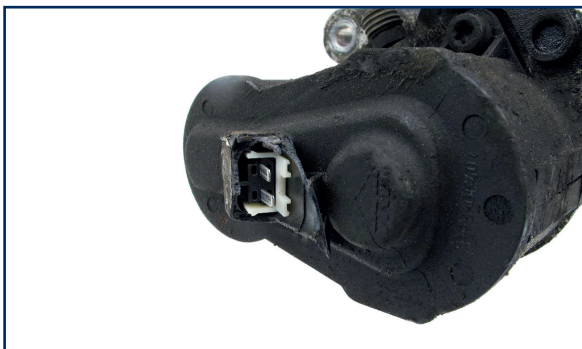
Damage or defects on the plug connector or motor for the electric hand brake.

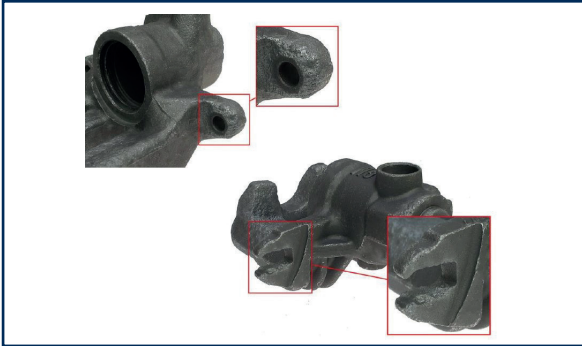
Corrosion damage on the surface of the connection for the guide pin.

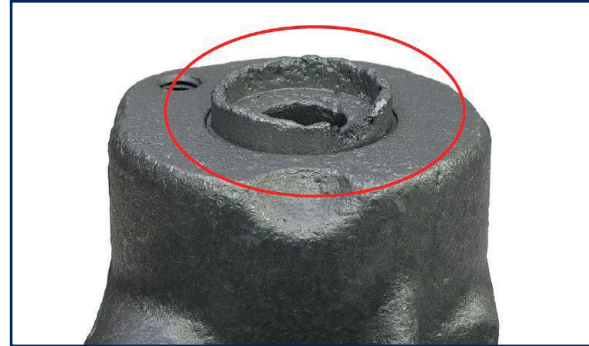
The inner cylindrical part has been corroded and is broken.

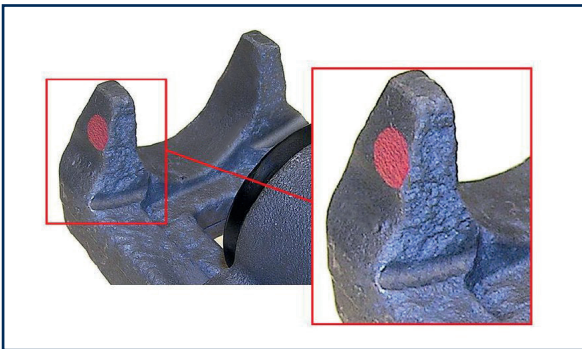
In this example, the plane-parallel contact surface for the brake pads is extremely corroded. The brake caliper can no longer be remanufactured.

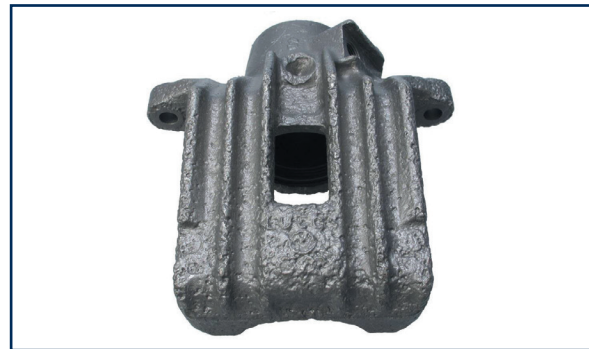
Severe corrosion/rust damage on the entire housing. The corrosion/rust damage must not be so severe that the surfaces have virtually eroded away and can no longer be reconditioned.

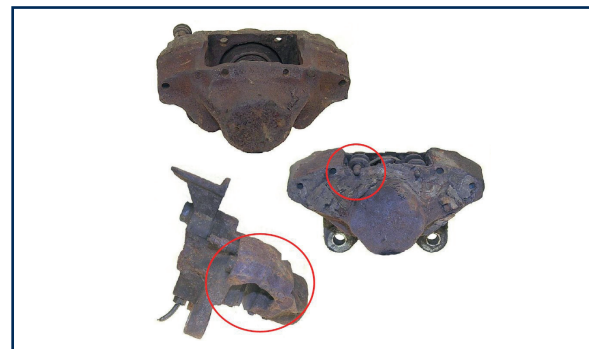
Examples of severe corrosion/rust damage on the entire housing, i.e. on the pin holes or surfaces for the brake pads. The corrosion/rust damage must not be so severe that the surfaces have virtually eroded away and can no longer be reconditioned.

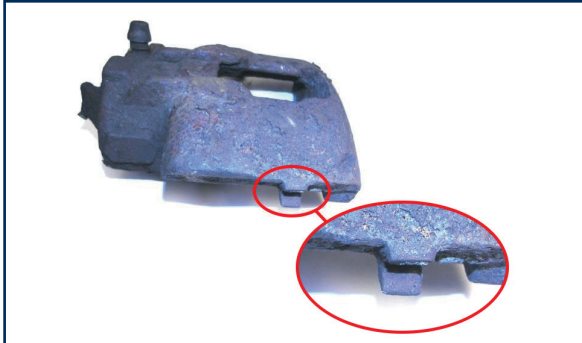
In this example, part of the brake caliper housing has been broken off and cannot be reconditioned.

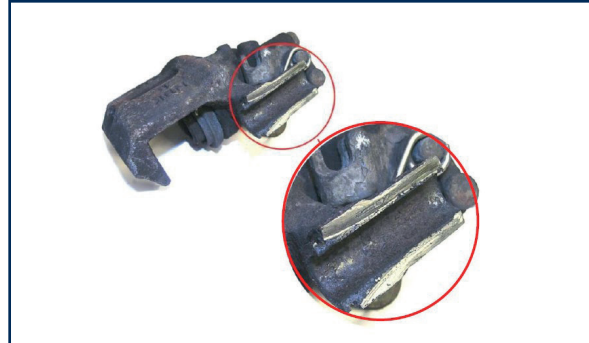
In this example, the guide sleeve housing has been destroyed.

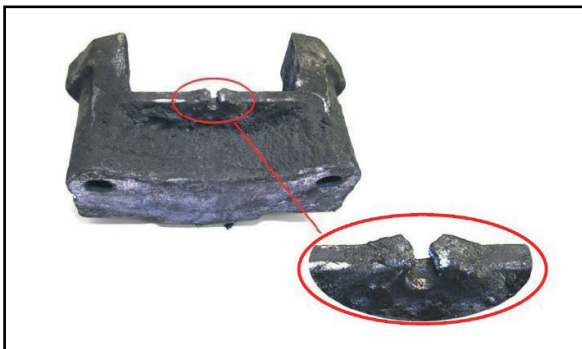
In this example, the opening for the fixing pin has been broken off/destroyed.

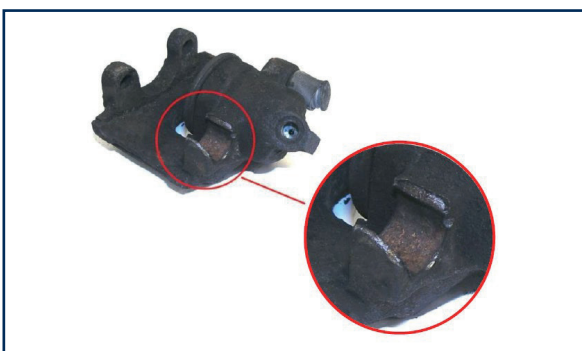
In this example, part of the brake caliper housing has been destroyed in the area of the guide sleeve.

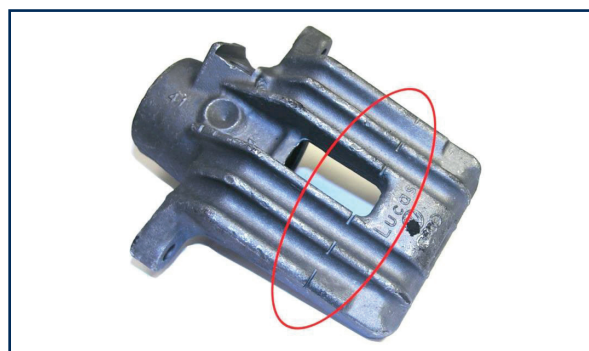
In this example, saw marks are visible on the brake caliper housing.

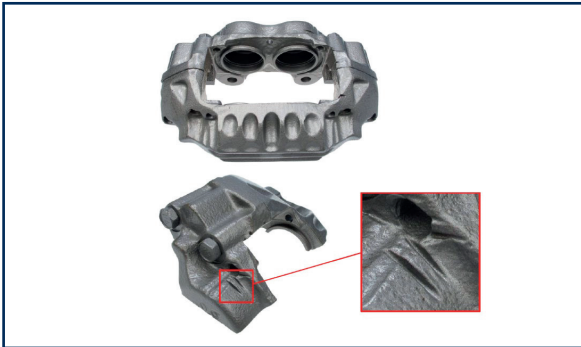
In this example, saw marks are visible on the brake caliper housing.

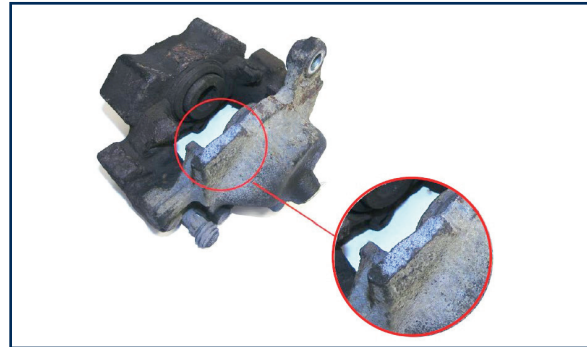
In this example, the guide sleeve housing has been destroyed.

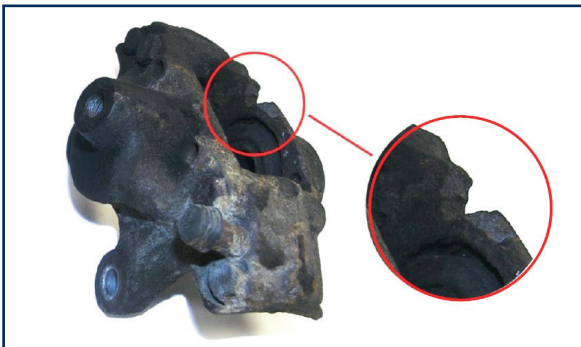
In this example, the opening for the fixing pin has been broken off/destroyed.

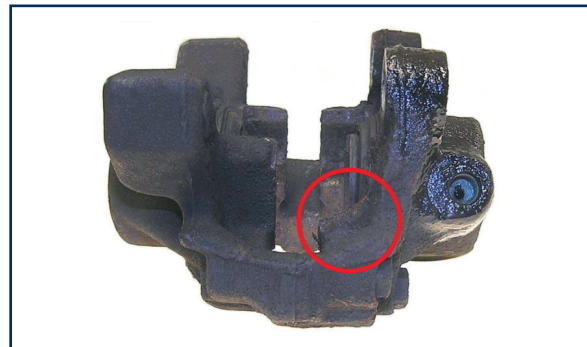
In this example, the sliding surface for the brake pads has been destroyed.

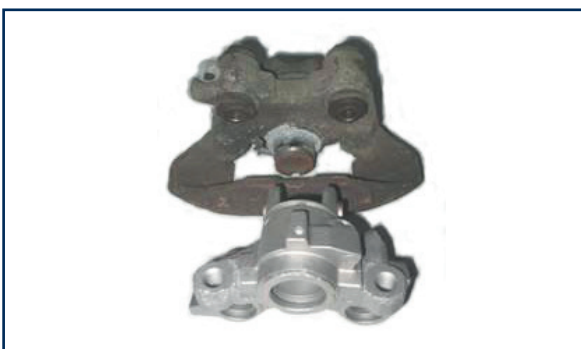
In this example, the brake caliper is incomplete and parts of the frame are missing.

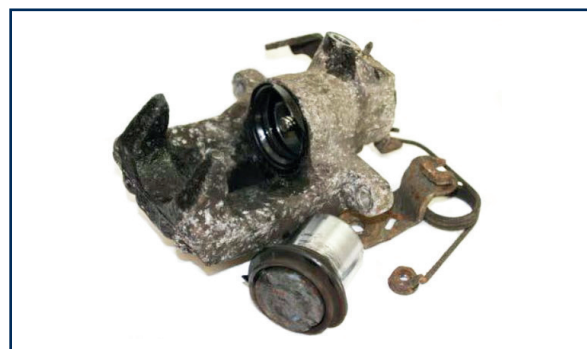
In this example, the brake caliper is incomplete and parts of the frame are missing.
