OPTIMAL®

Unacceptable:

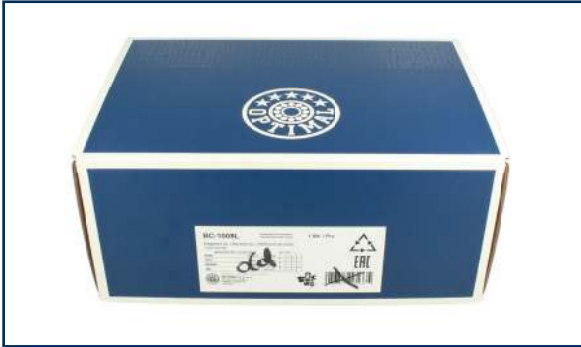
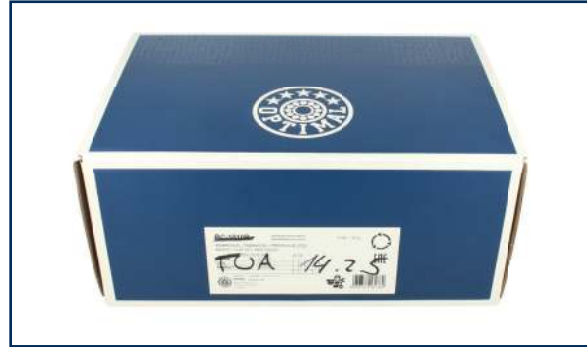
Illegible barcode:

The original barcode on the box must not be covered in any way. The brake calipers will be rejected if the barcode cannot be read by a scanner.

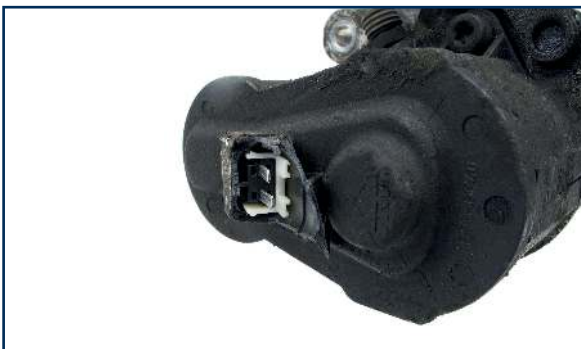
Damage or defects on the plug connector or motor for the electric hand brake.

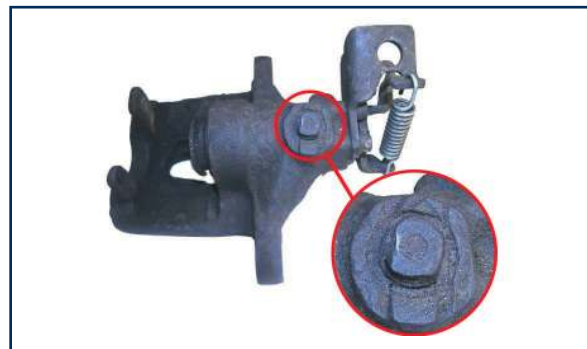
In this example, a bolt has been used. The thread is defective and toolmarks are visible.

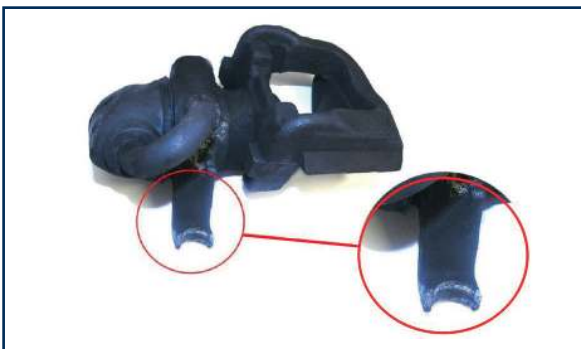
In this example, the guide for the handbrake cable has broken off.

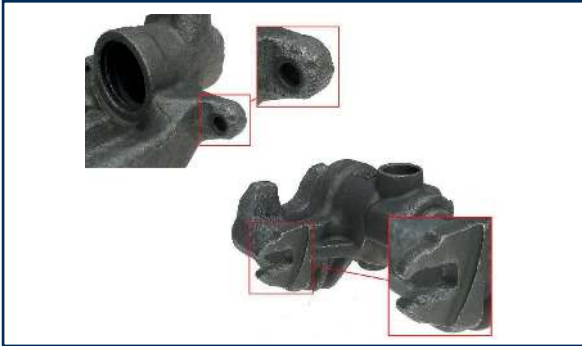
Corrosion damage on the surface of the connection for the guide pin.

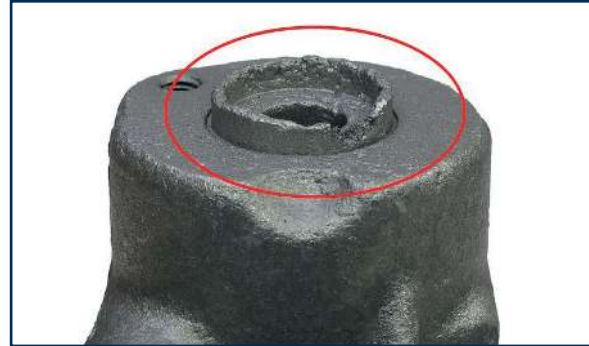
The inner cylindrical part has been corroded and is broken.

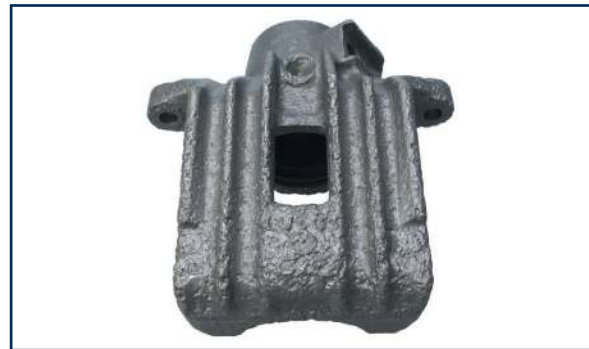
Severe corrosion/rust damage on the entire housing. The corrosion/rust damage must not be so severe that the surfaces have virtually eroded away and can no longer be reconditioned.

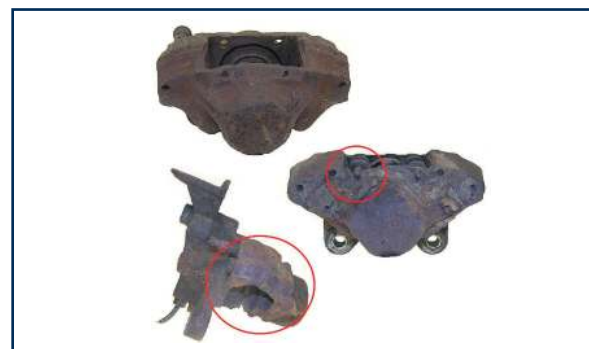
Examples of severe corrosion/rust damage on the entire housing, i.e. on the pin holes or surfaces for the brake pads. The corrosion/rust damage must not be so severe that the surfaces have virtually eroded away and can no longer be reconditioned.

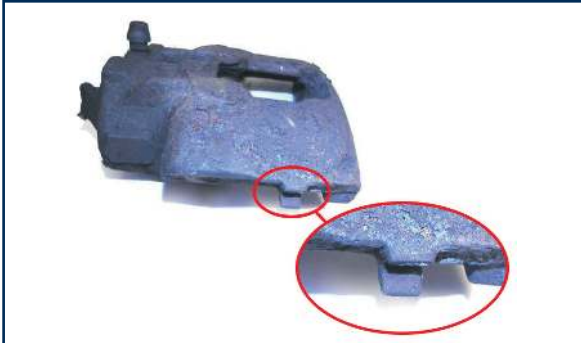
In this example, part of the brake caliper housing has been broken off and cannot be reconditioned.

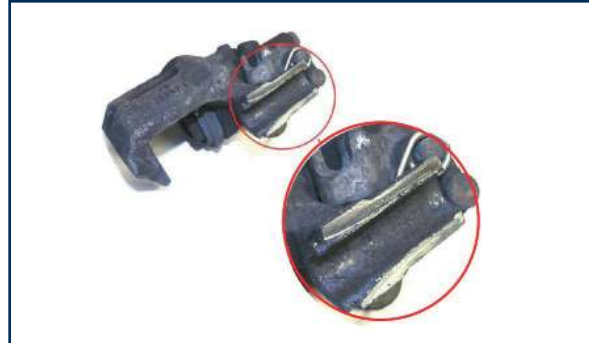
In this example, the guide sleeve housing has been destroyed.

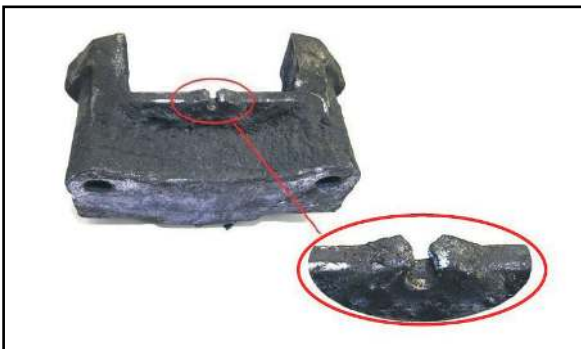
In this example, the opening for the fixing pin has been broken off/destroyed.

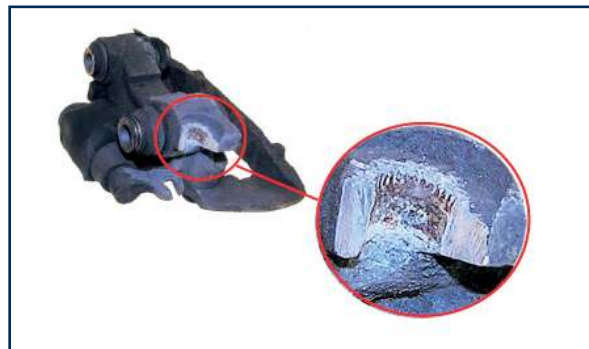
In this example, the guide/mounting for the handbrake cable on the brake caliper housing has been destroyed.

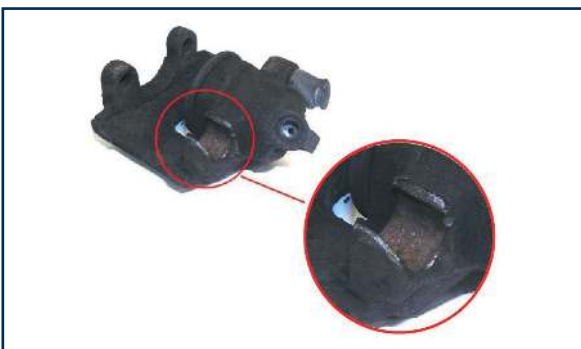
In this example, part of the brake caliper housing has been destroyed in the area of the guide sleeve.

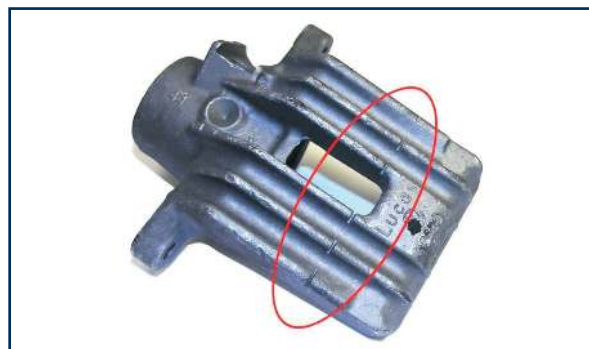
In this example, saw marks are visible on the brake caliper housing.

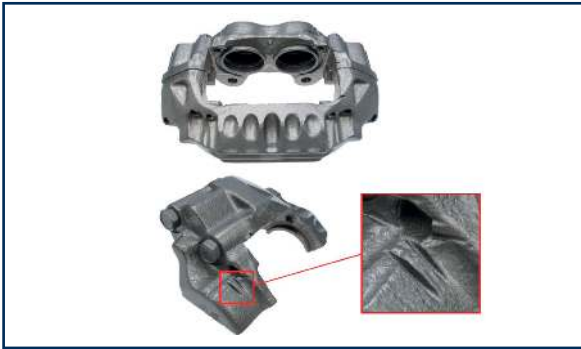
In this example, saw marks are visible on the brake caliper housing.

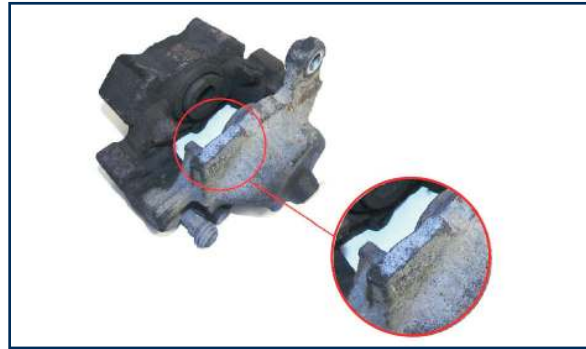
In this example, the guide sleeve housing has been destroyed.

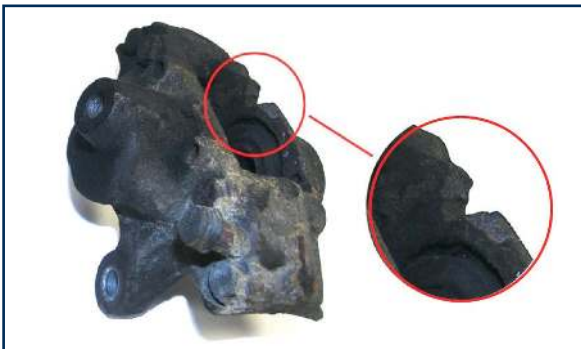
In this example, the opening for the fixing pin has been broken off/destroyed.

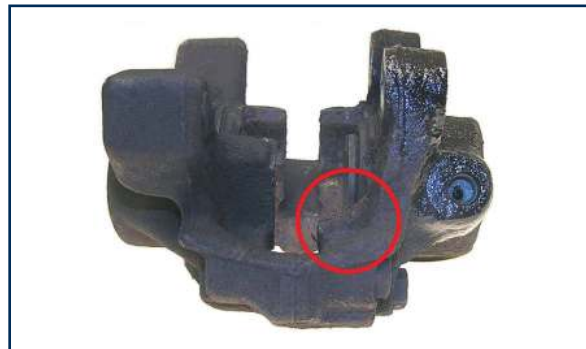
In this example, the sliding surface for the brake pads has been destroyed.

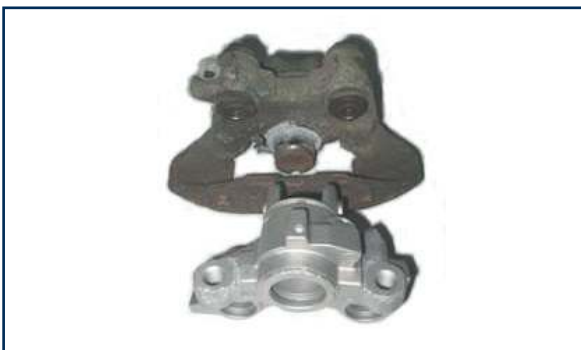
In this example, the brake caliper is incomplete and parts of the frame are missing.

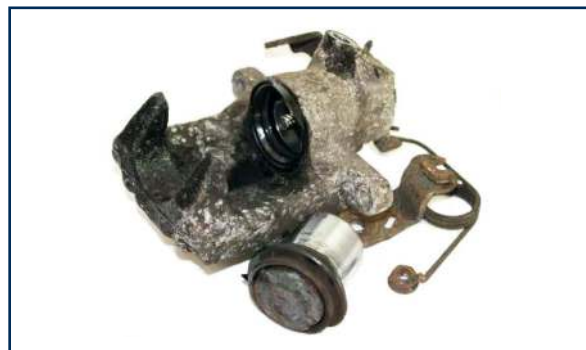
In this example, the brake caliper is incomplete and parts of the frame are missing.
