PSA rear axle repair kits

Rear axle repair: OPTIMAL makes it possible

Technical-Tip: 01/16
Pictures: OPTIMAL Automotive

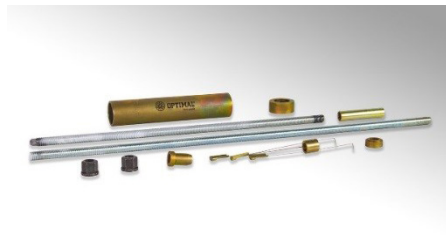
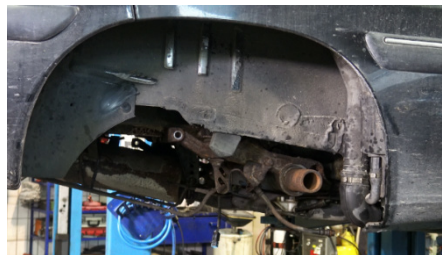
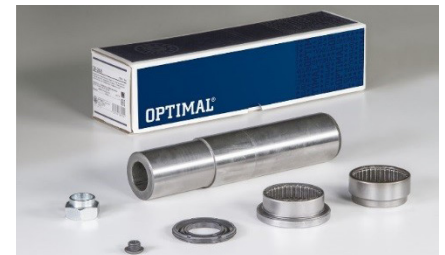
It is cheaper and more efficient to repair the rear axle using the new PSA repair kits by OPTIMAL. In cooperation with Paschke Profitec, OPTIMAL engineers have developed a nonwearing and cost-effective tool (reference no. WKZ-1111S), enabling an economical repair to be carried out (see photo below).

- ✓ Low-cost vehicle repair
- ✓ No need to remove the rear axle
- ✓ Low tool costs
- ✓ Repair on one side possible (left/right)
- ✓ Complete kit in a single pack
- ✓ Assembly instructions enclosed with link to repair video
- ✓ Assembly can also be performed using other tools
- ✓ All components manufactured in comparable OE quality

- ✓ **No welding** is necessary for pulling the axle journals
- ✓ Long pressure pipe, meaning greater distance to the side part and 360° turns possible
- ✓ Wear-resistant spindle with standard metric thread saves time thanks to a greater transmission ratio Wof strength and rotation angle
- ✓ The standard thread means there is no self-locking effect (as is the case with fine threads)
- ✓ The spindle has a hexagon allowing it to be countered
- ✓ Torsion-proof spindle nuts (driving nut)
- ✓ Axial bearing unit encapsulated in pressure piece for greater dirt protection
- ✓ A sophisticated stub shaft pulling procedure makes exchanging on one vehicle side possible
- ✓ The mechanical tool can be adapted to common hydraulic hollow piston cylinders (less effort required, huge time saving)
