Control arms for VW Polo 6N1, VW Polo 6N2, VW Lupo and SEAT Arosa

It is important to identify the correct part

Technical-Tip: 01/21 Pictures: OPTIMAL Automotive GmbH

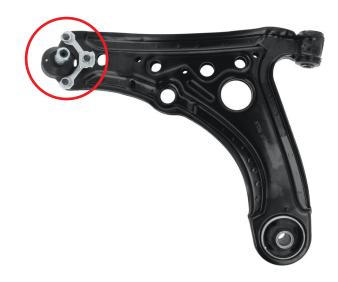
This Technical Tip shows you why the original rim size, the chassis number and the PR code are important for identifying steering and suspension parts for certain uses. The examples provided below show how to identify the right complete control arm for use in various SEAT and VW vehicles. The side on which the ball joint is installed varies depending on the brake system.
