PSA rear axle repair kits

Rear axle repair: OPTIMAL makes it possible

Technical-Tip: 01/16
Pictures: OPTIMAL Automotive

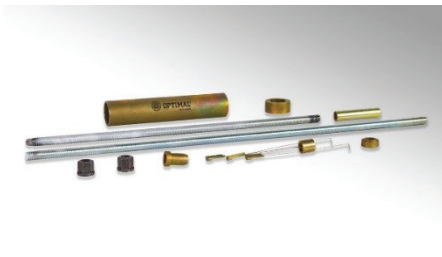
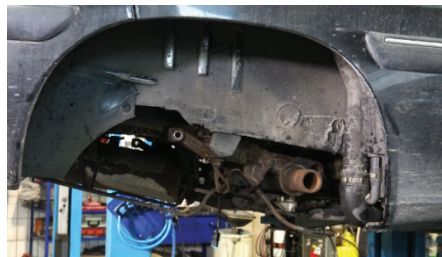
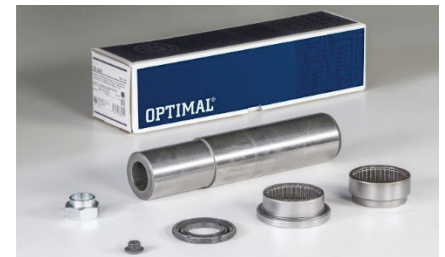
It is cheaper and more efficient to repair the rear axle using the new PSA repair kits by OPTIMAL. In cooperation with Paschke Profitec, OPTIMAL engineers have developed a nonwearing and cost-effective tool (reference no. WKZ-1111S), enabling an economical repair to be carried out (see photo below).

- ✓ **No welding** is necessary for pulling the axle journals
- ✓ Long pressure pipe, meaning greater distance to the side part and 360° turns possible
- ✓ Wear-resistant spindle with standard metric thread saves time thanks to a greater transmission ratio Wof strength and rotation angle
- ✓ The standard thread means there is no self-locking effect (as is the case with fine threads)
- ✓ The spindle has a hexagon allowing it to be countered
- ✓ Torsion-proof spindle nuts (driving nut)
- ✓ Axial bearing unit encapsulated in pressure piece for greater dirt protection
- ✓ A sophisticated stub shaft pulling procedure makes exchanging on one vehicle side possible
- ✓ The mechanical tool can be adapted to common hydraulic hollow piston cylinders (less effort required, huge time saving)
